Arlon Products Training- Product Defects
Created by Quality Dept. Dec 2019

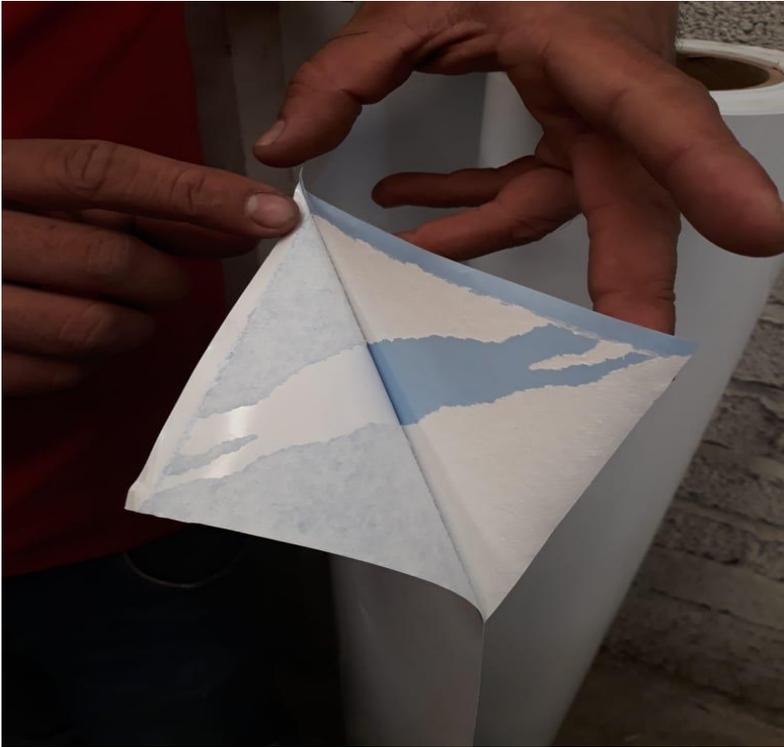
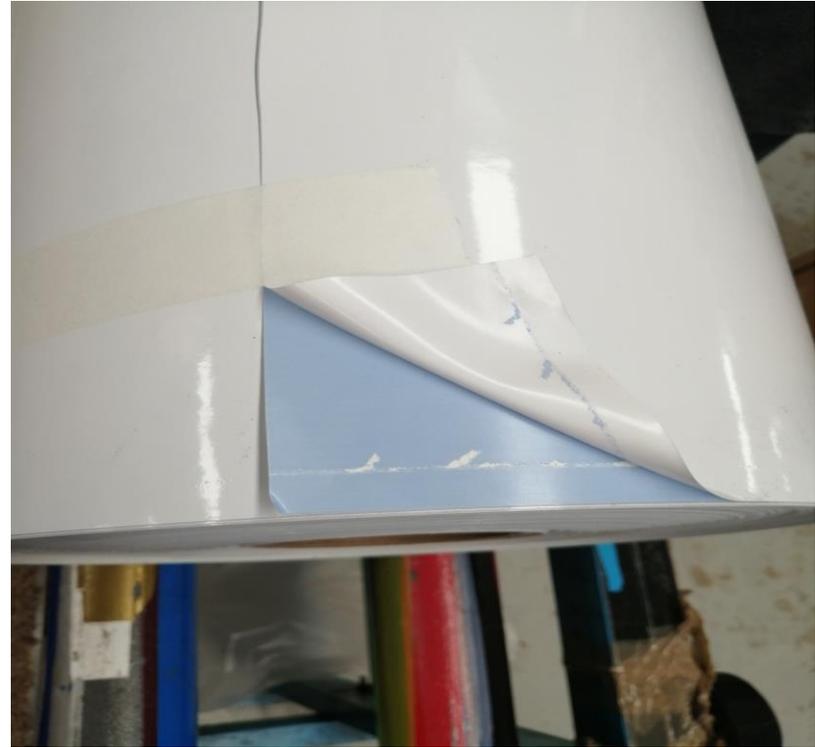
Liner Scuffing:

Root cause – silicone sensitivity to scratching during coating

Corrections – wider liner, on line coating set up stain test edge to edge

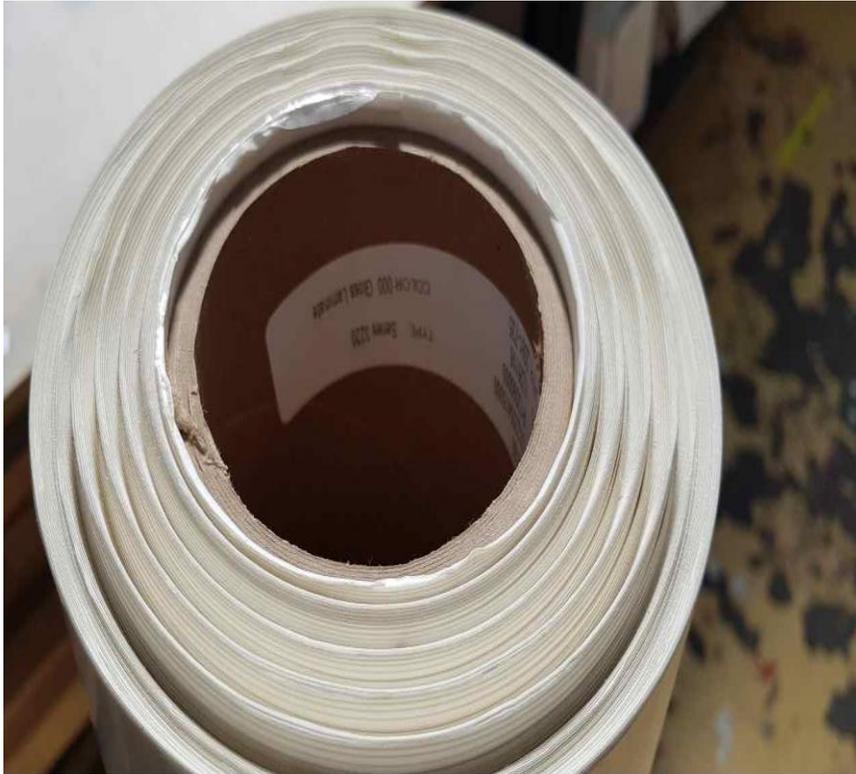
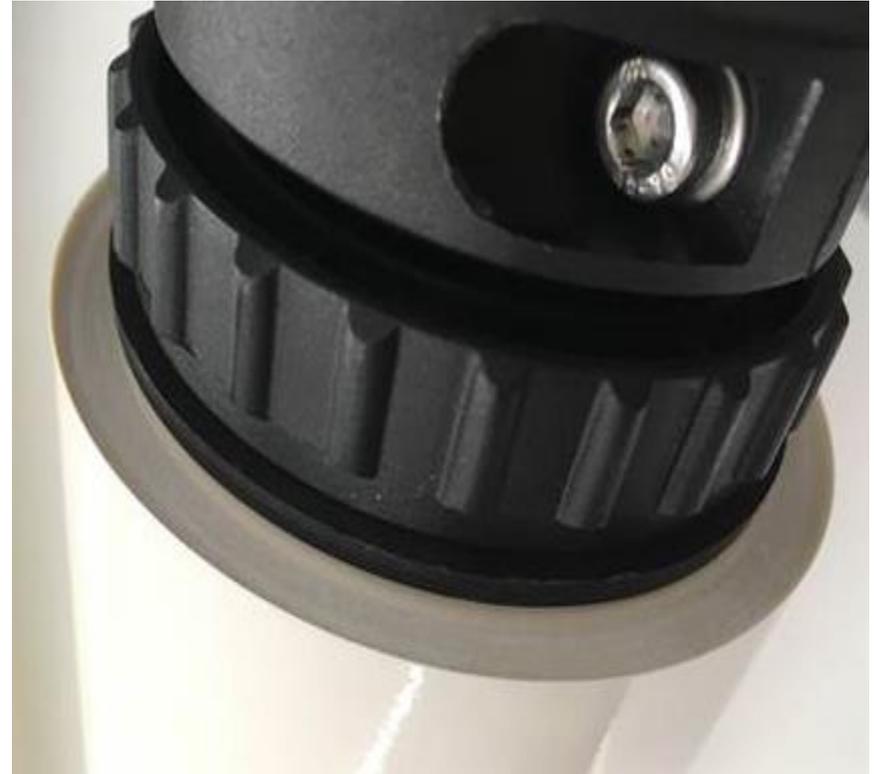
Wavy Edge Rolls/Telescope rolls:

Root cause – uneven tension and core slips during winding

Corrections – control winding tension, shaft modification to prevent core slips, new 736 produces even rolls

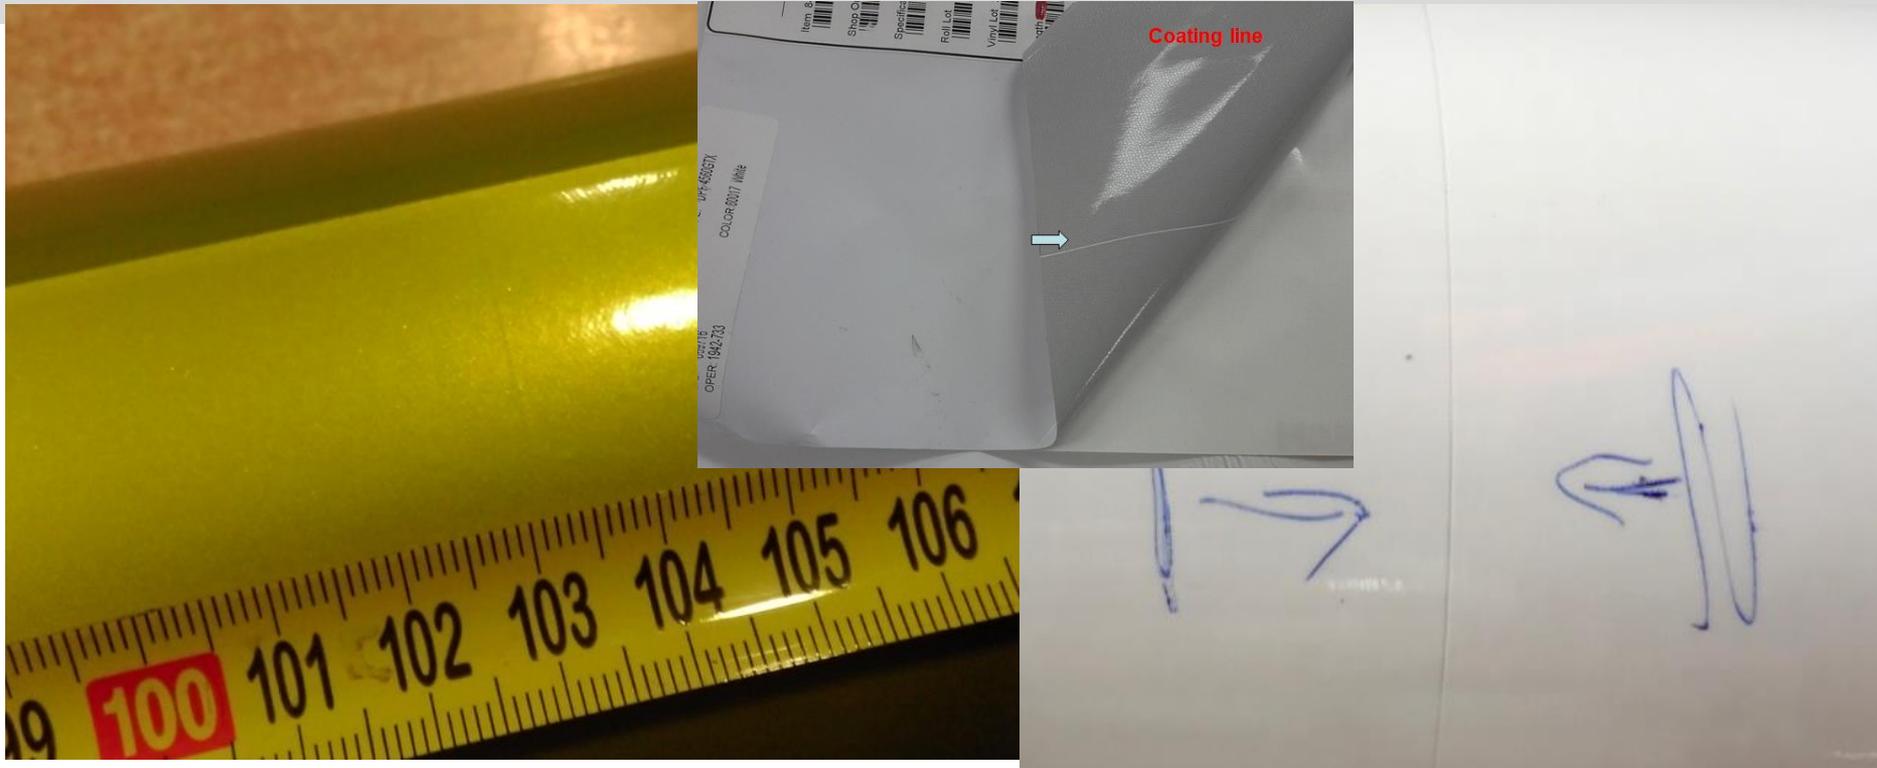
Lines/Sreaks:

Root cause:

Cast lines – particle caught under the knife, or cast roller not turning

Coat lines – particle caught under the knife, contamination in the adhesive, or coat roller not turning

Corrections:

Clean set up, effective filtration, inspect beginning of run for scratches, flag if not corrected then converting to remove defect

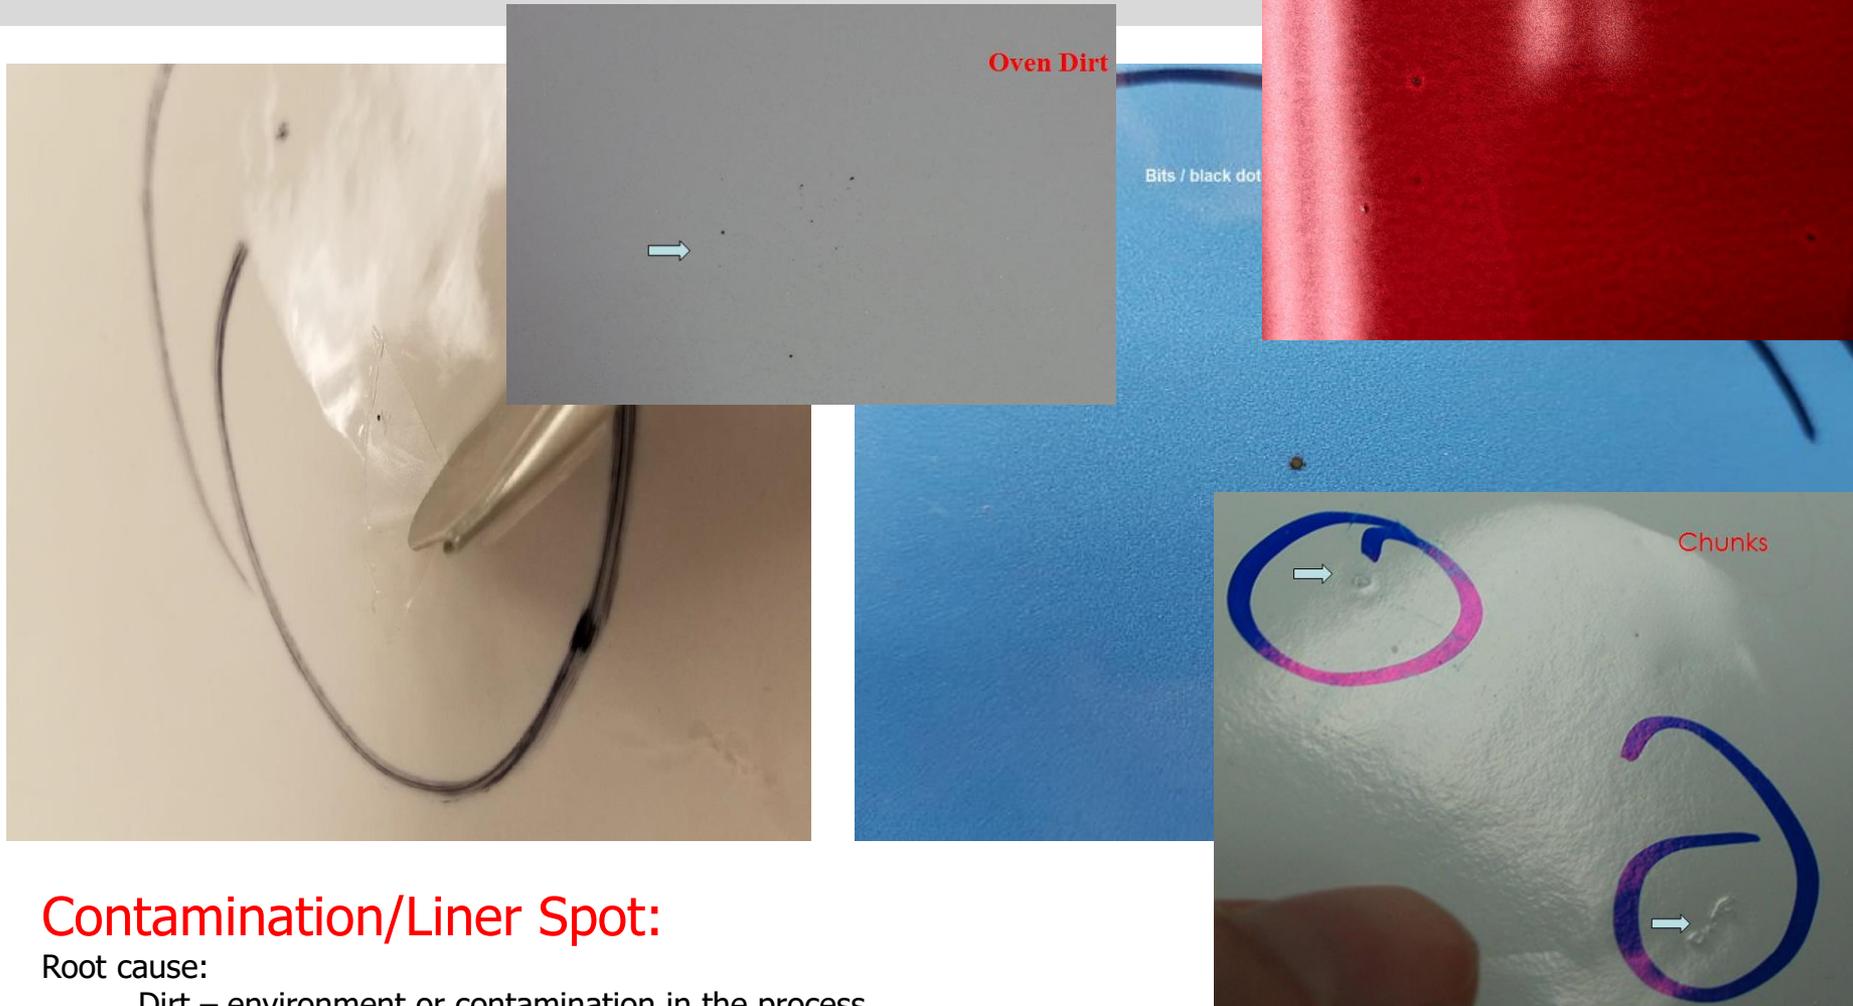
Contamination/Liner Spot:

Root cause:

Dirt – environment or contamination in the process

Liner spot - the spots are a byproduct of the paper making process and are inherent to paper liners

Corrections:

Dirt – more effective process area cleaning, set up

Liner spot – educate customer the “no impact to product quality and application” or change liner

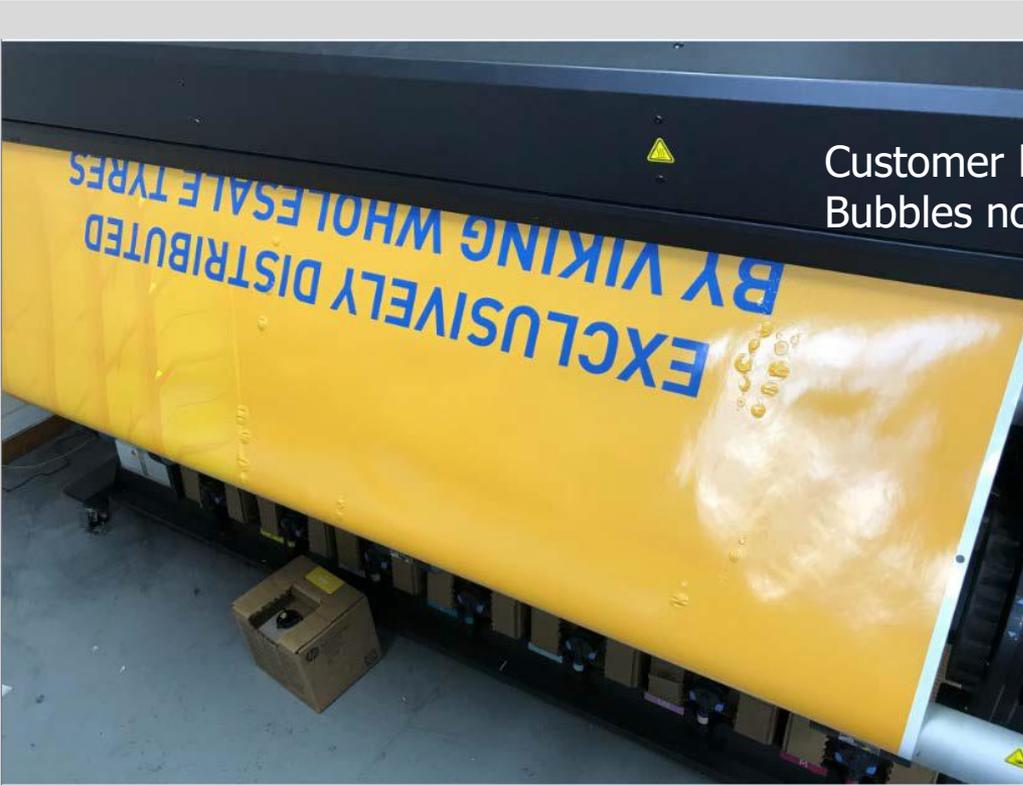
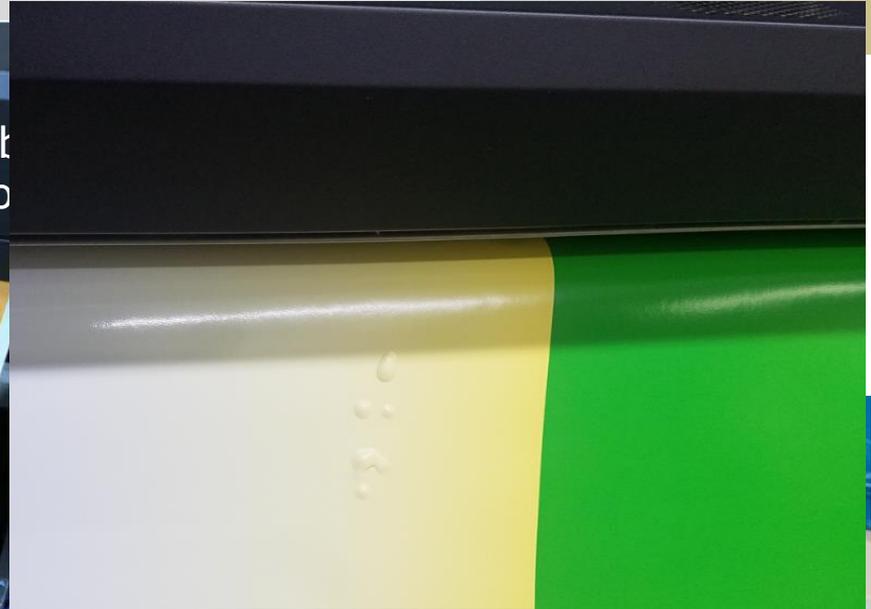
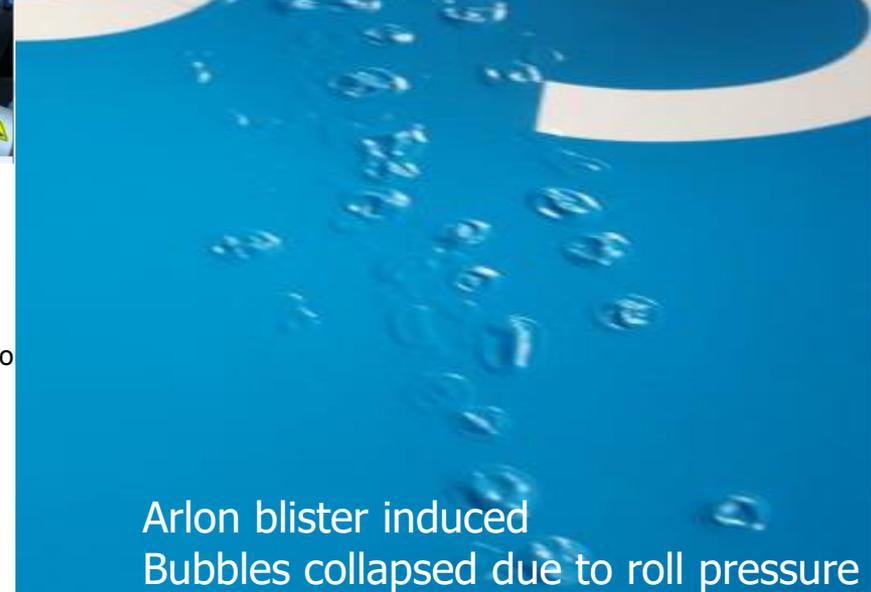
Blister:

Root cause:

During printing – incorrect printer heater setting or uneven heating
Before printing – internal blister during FG rolls converting and was not taken out prior to shipment

Arlon blister induced
Bubbles collapsed due to roll pressure

Corrections:

At Customer – set printer heater setting properly- Mostly Latex printer related
At Arlon – corrected with auto stop and auto cooling fan since June 2018.

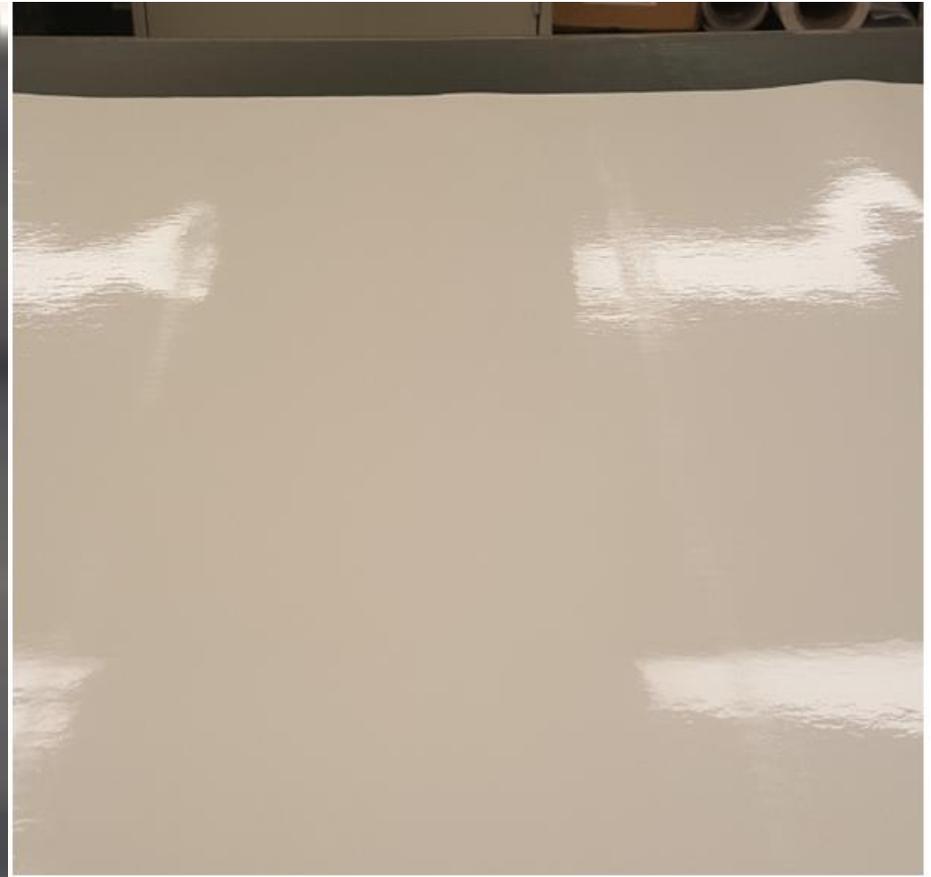
Box Corrugation/Box pressure marks

Root cause: Mixed/Uneven pressure load during storage

Corrections: Stronger packaging construction and/or utilize best practice on storage and shipment method

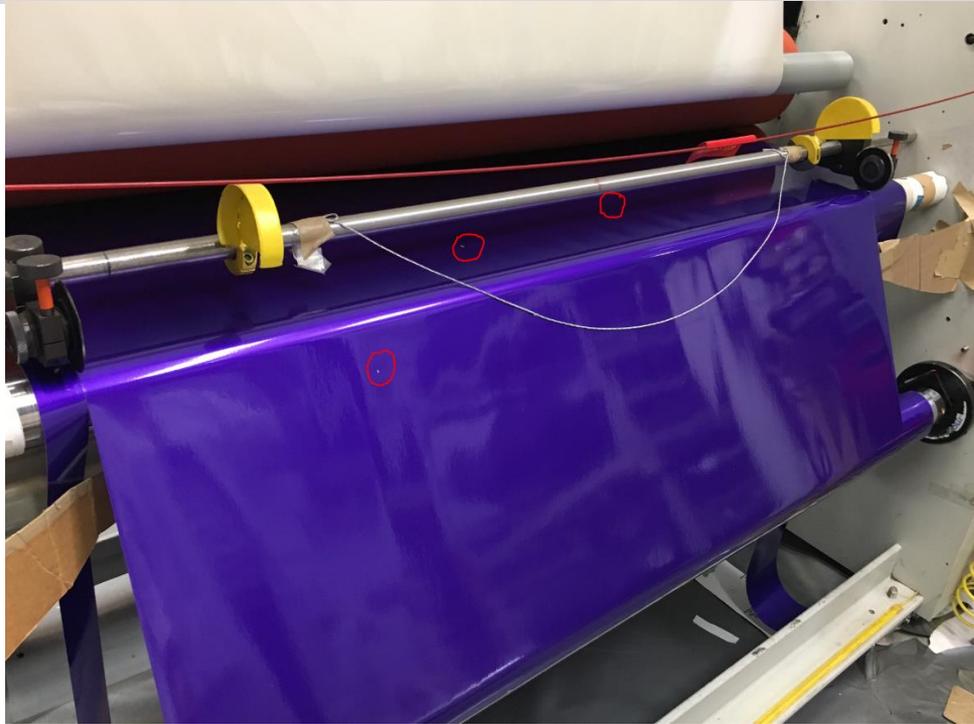
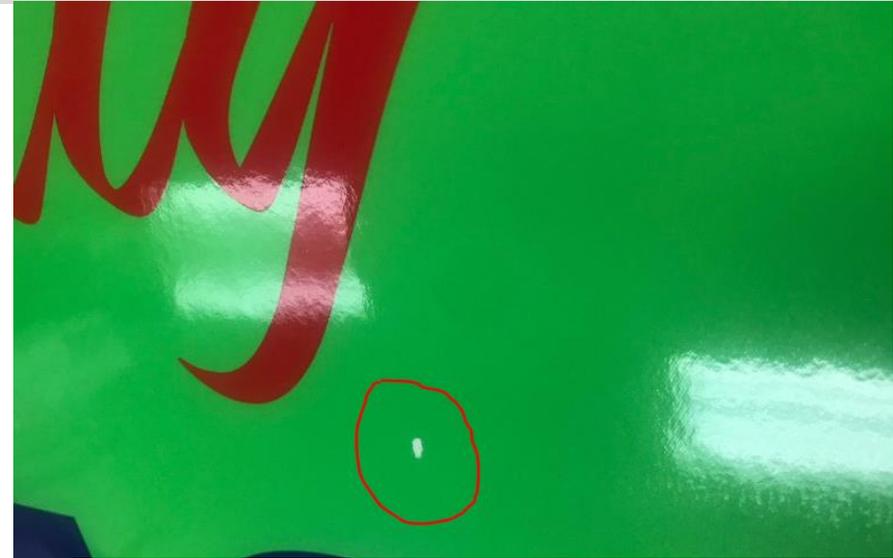
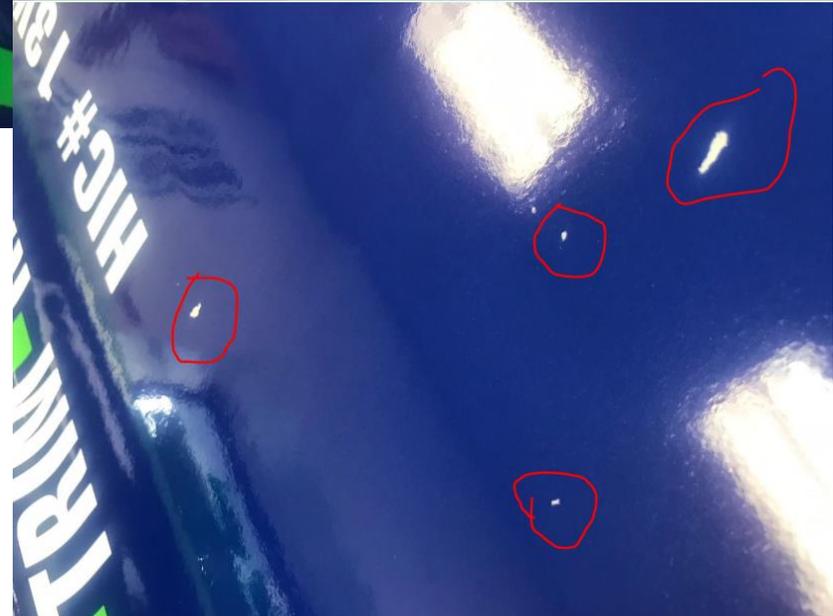
Silicone Void (overlam liner):

Root cause: Base paper liner supplier roll processing contaminated

Corrections: RM supplier incoming base paper supply inspection optimized

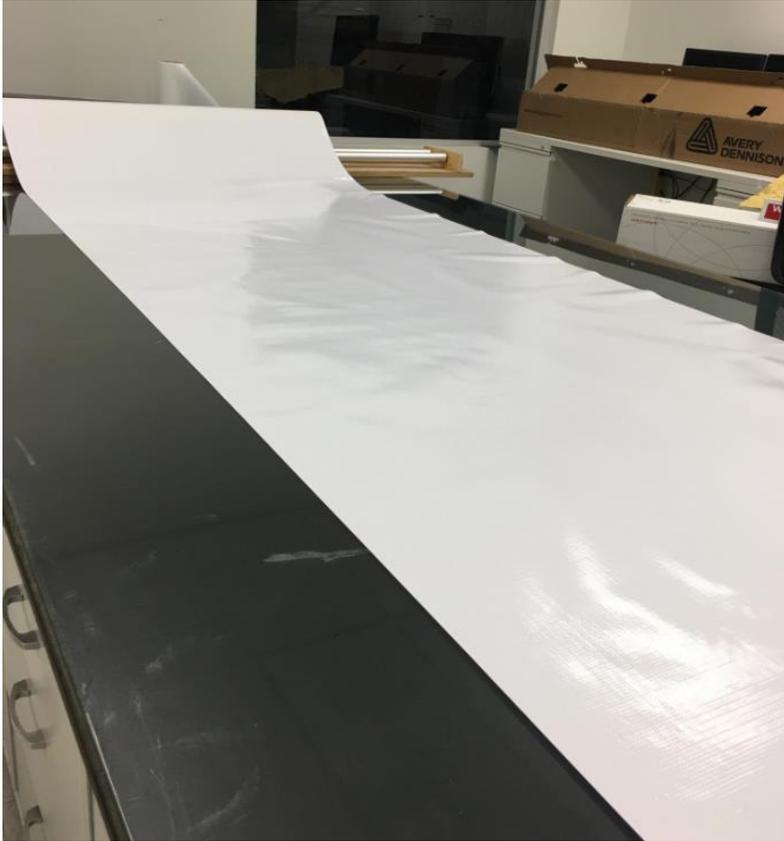
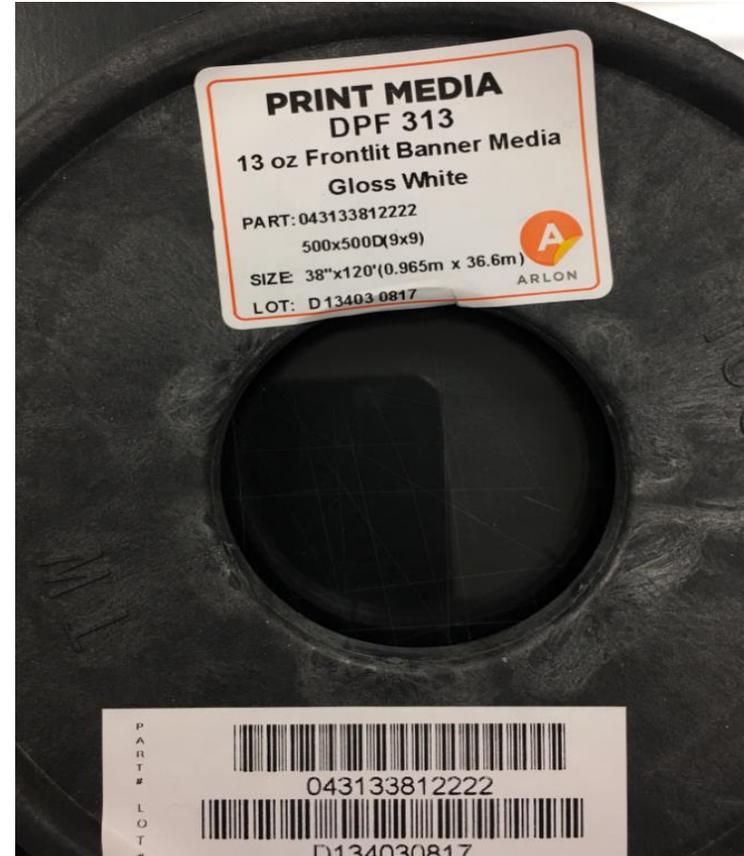
Banner Waffling:

Root cause – uneven tension during winding or inconsistent caliper during manufacturing

Corrections – control winding tension, improve thickness profile across the web

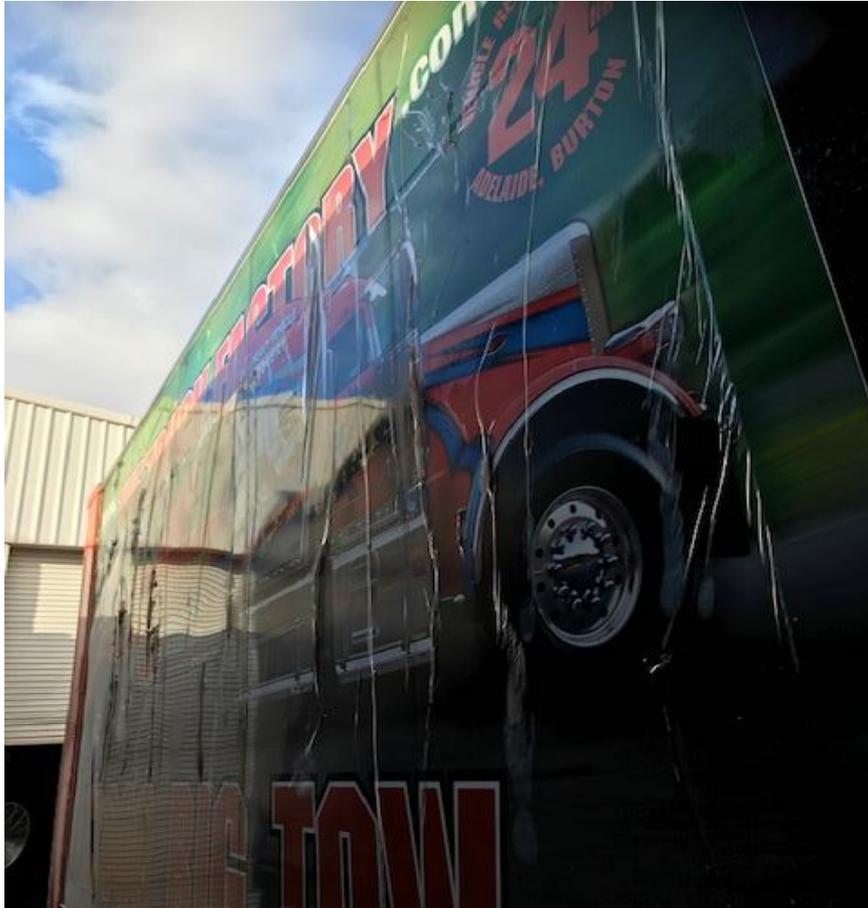
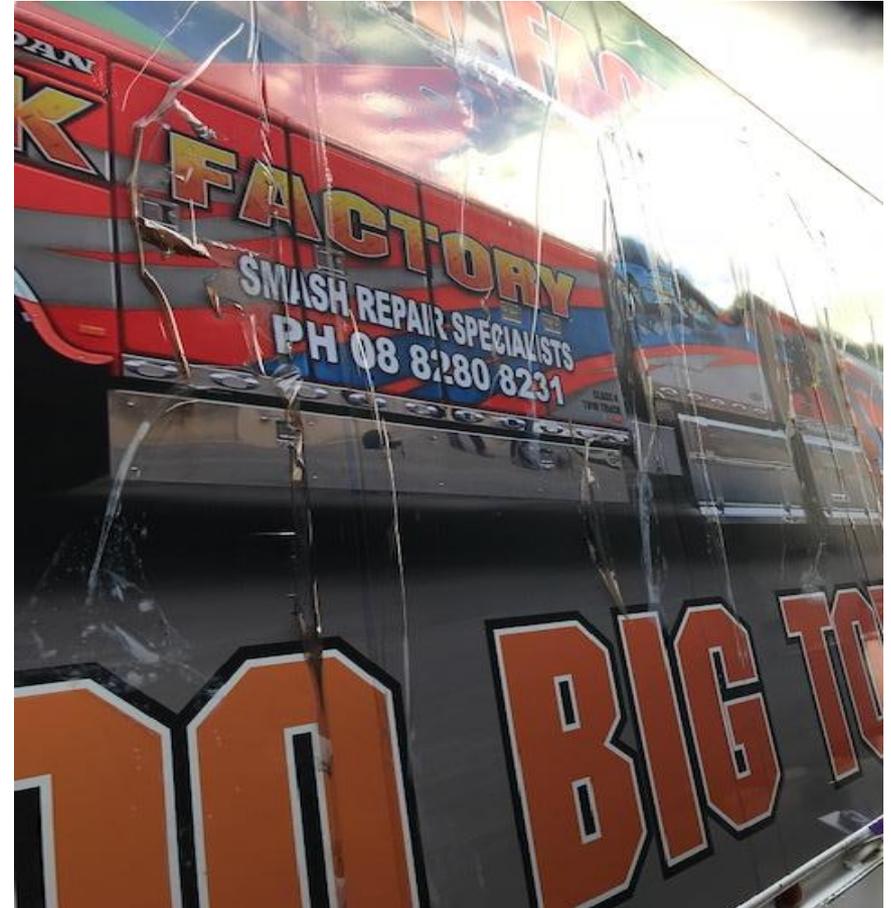
Overlam lifting from Print Media

Root cause: Incomplete outgassing process prior to overlam lamination
Corrections: Complete dry solvent ink prior to lamination

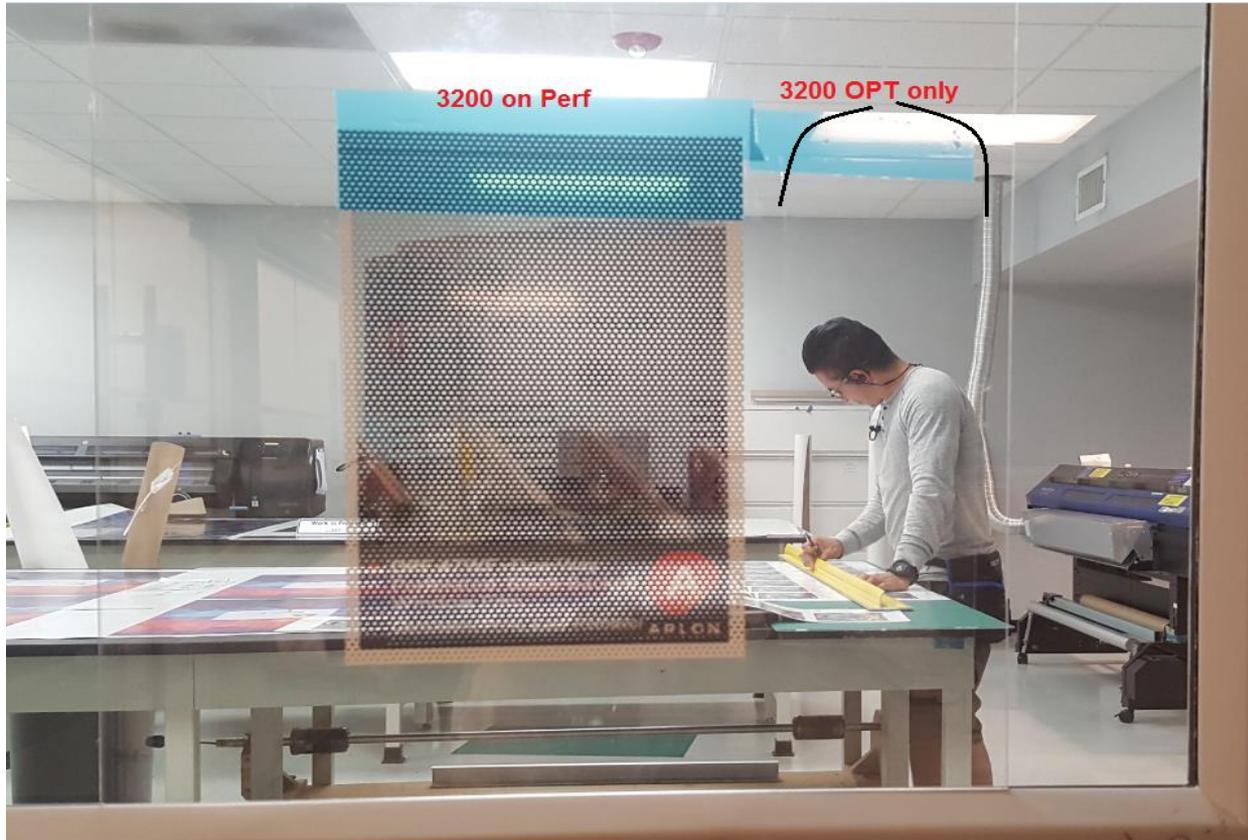
OPT 3200: Not Optically Clear enough

Root cause: Incorrect customer expectations

Corrections: OPT Clear must be applied to a smooth, flat, glass-like substrate for the clarity to be optimized. Any roughness or texture to the substrate will interfere with the clarity. Application to a perfed product cannot result in optimal clarity. This is because of the lens effect created by the holes in the perfed material. When laminating the 3200, the holes in the perf create a concavity or lens shape to the film. This concavity is what will slightly distort the image

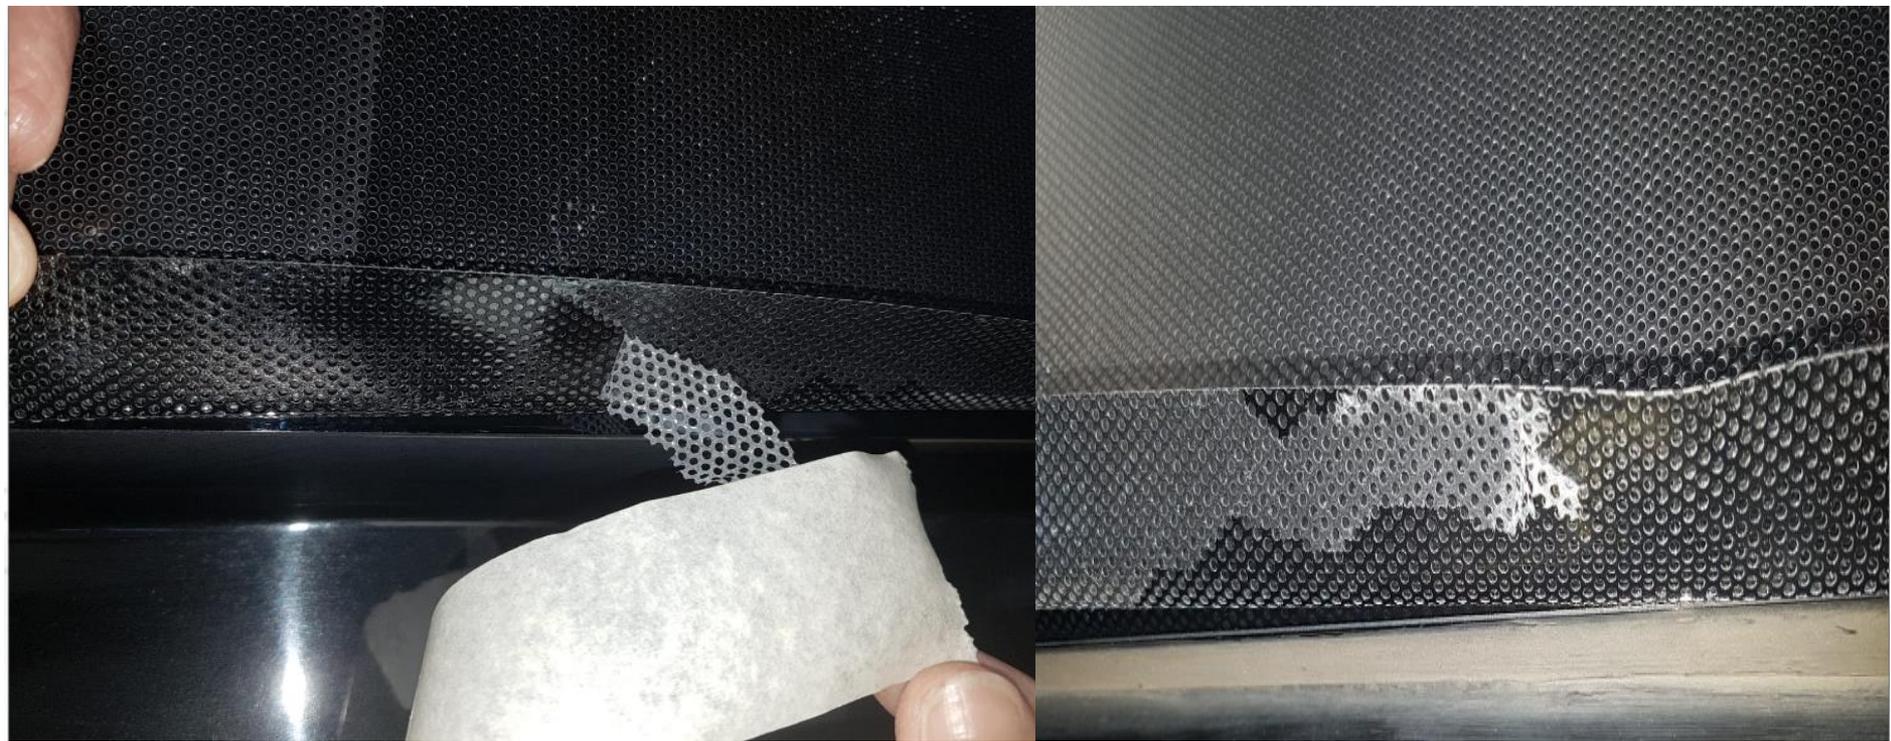
DPF 45WF: Liner Splitting

Root cause: Material age and weak liner construction

Corrections: Short shelf life and improve liner of buyout window film

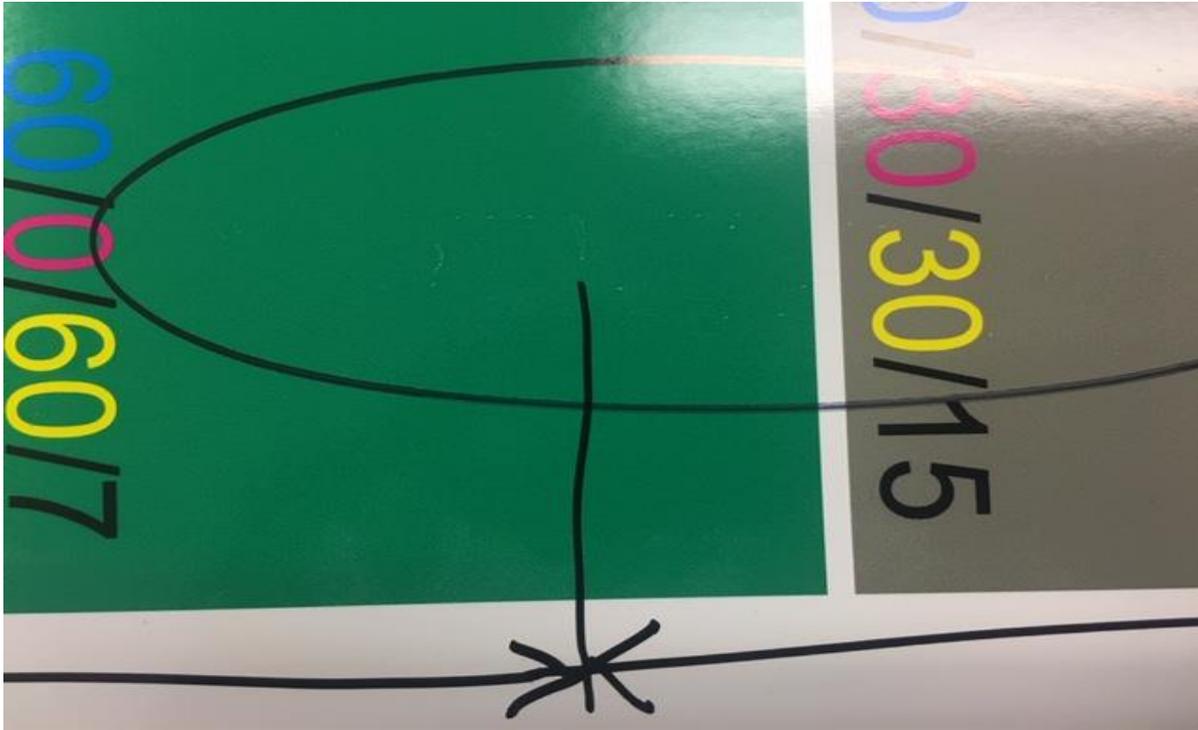
Print Contamination

Root cause;
Airborne environment contamination at customer or at Arlon

Correction:
Follow best practice and frequent cleaning during DPF run at converting.

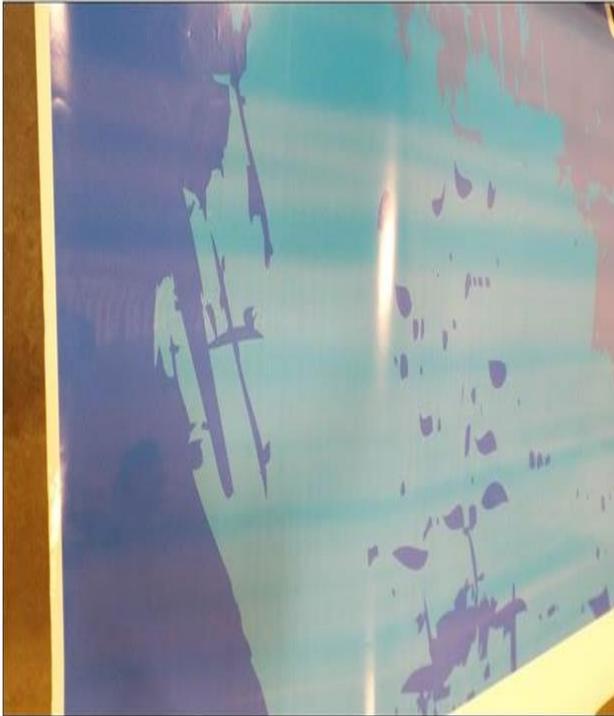
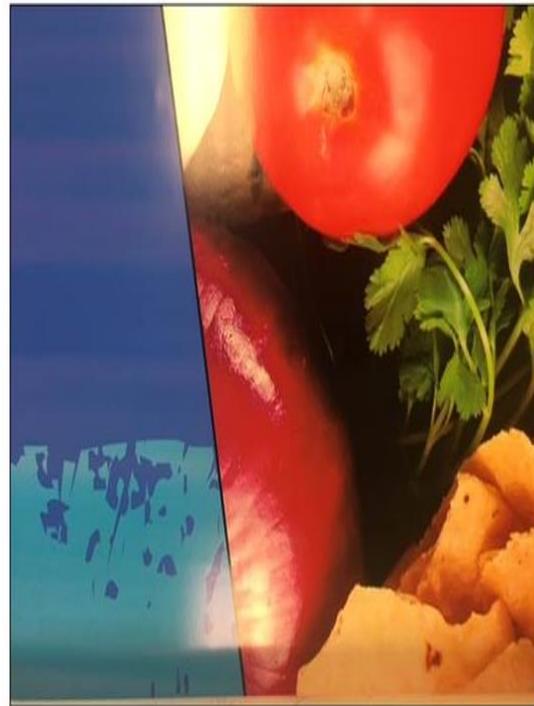
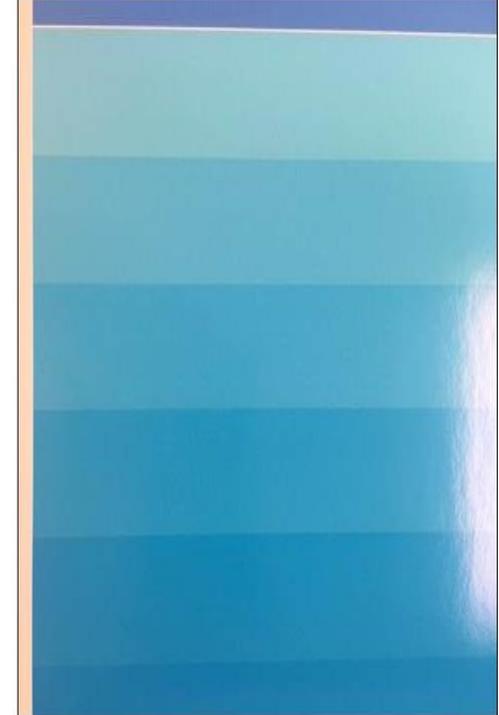
Customer Print Result 1 – Claim

Customer Print Result 2 – Claim

Arlon Print Evaluation Result - from Customer returned SLX roll

Uneven print/Streaks on printed graphics: Ink Starvation

Root cause: high volume of materials being printed by the printer and the print head for the light cyan and cyan cannot anymore sufficiently send and lay the volume of ink in the vinyl. It may be caused by lines or heads clogging and no more or less inks coming out from the nozzle.

Correction: optimize printer setting

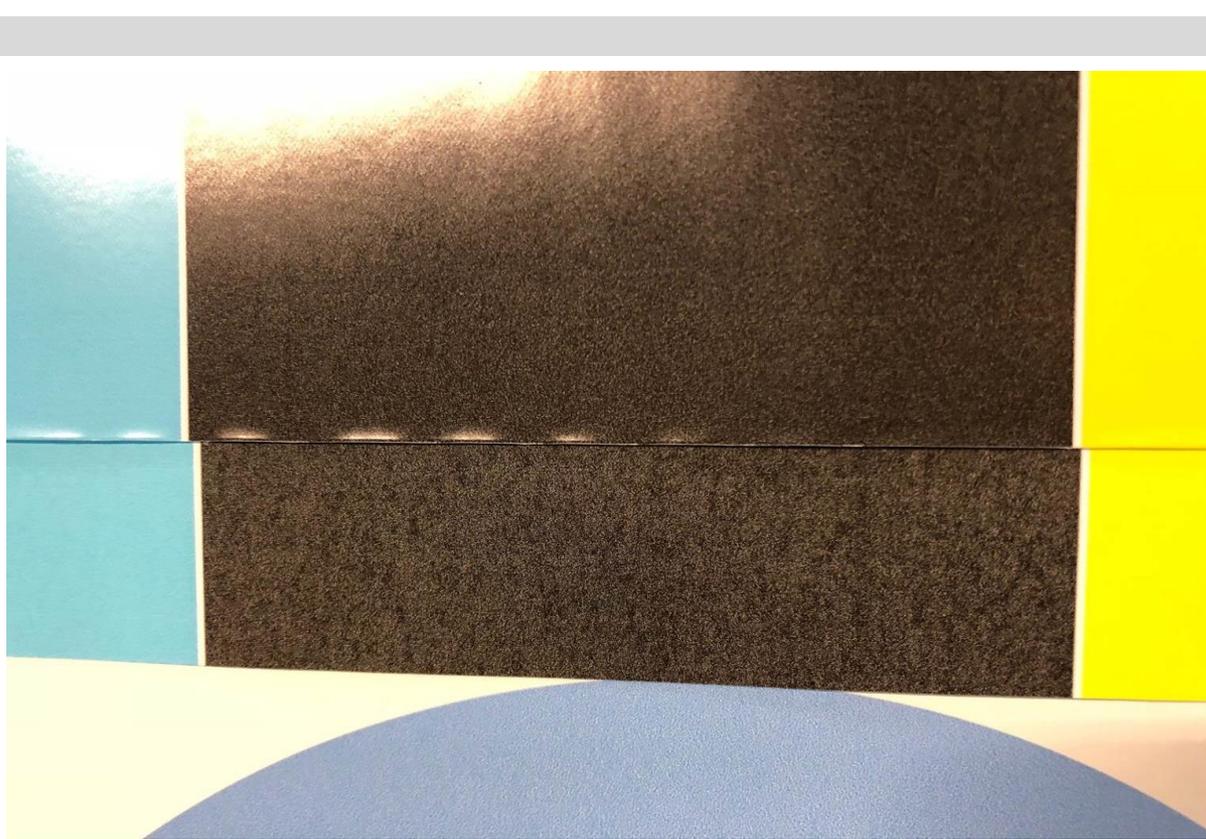
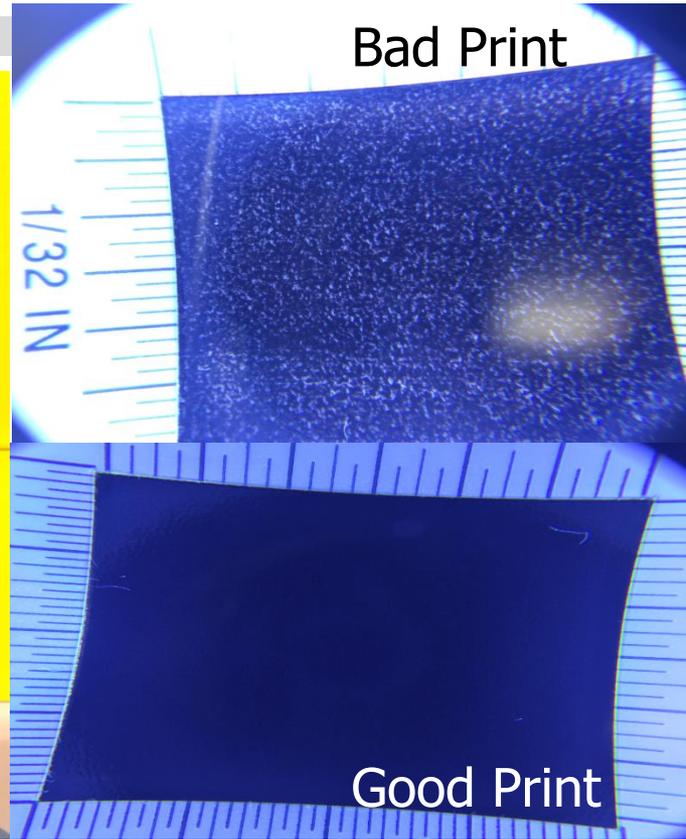
Ink Rejection:

Root cause:

Unstable print media due to migratory component in the film and process material.

Correction:

Product development media optimization.

Manage shelf life and aging inventory.
